The Effect of Substrate Contaminates on the Life of Epoxy Coatings Submerged in Sea Water

The Effects Of Substrate Contaminants On The Life Of Epoxy Coatings Submerged In Sea Water

NATIONAL SHIPBUILDING RESEARCH PROGRAM

Prepared By:
DR. GERALD CARL SOLTZ
G C S CORROSION CONSULTANTS INC.
3 COOPER DRIVE, HOWELL, NEW JERSEY 07731

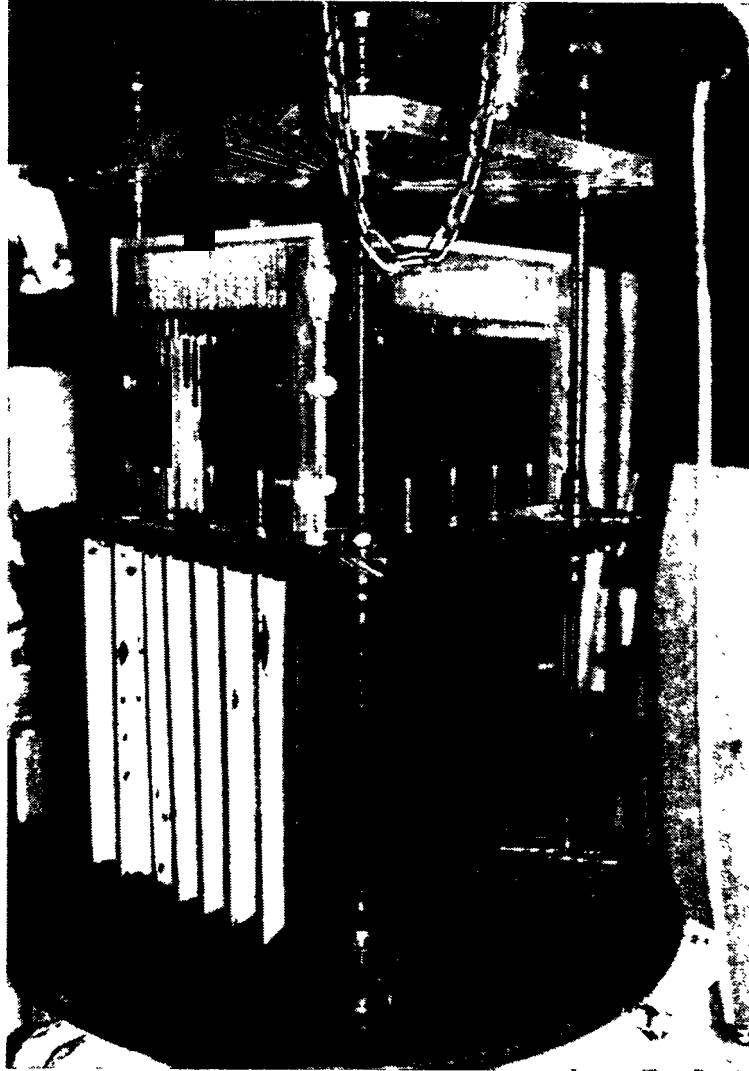
PANEL TEST RACK
& SUB-TANK

VIEW OF TANK COVER FITTED WITH TEST RACK & SUB-TANK
The test rack is permanently attached to the cover of the tank via 4 support rods and a support plate. It consists of three 1 inch thick plexiglas plates that have been slotted to hold Up to 144 - 12 x 6" test panels. The test setup can also hold less panels and a plexiglass sub-tank, 'which can be seen on the upper test rack. A different fluid is put into the sub-tank. This arrangement permits simultaneous testing of panels in two media such as salt water in the main tank and distilled water in the sub-tank. The sub-tank is partly submerged in the main tank's test liquid to keep temperatures constant.
